The Werribee River *'A Stream of Litter'*

Werribee Diversion Weir to Werribee Park Historical Ford 2014-2015

A Werribee Riverkeeper/ Deakin Uni Project 2014 - 2015

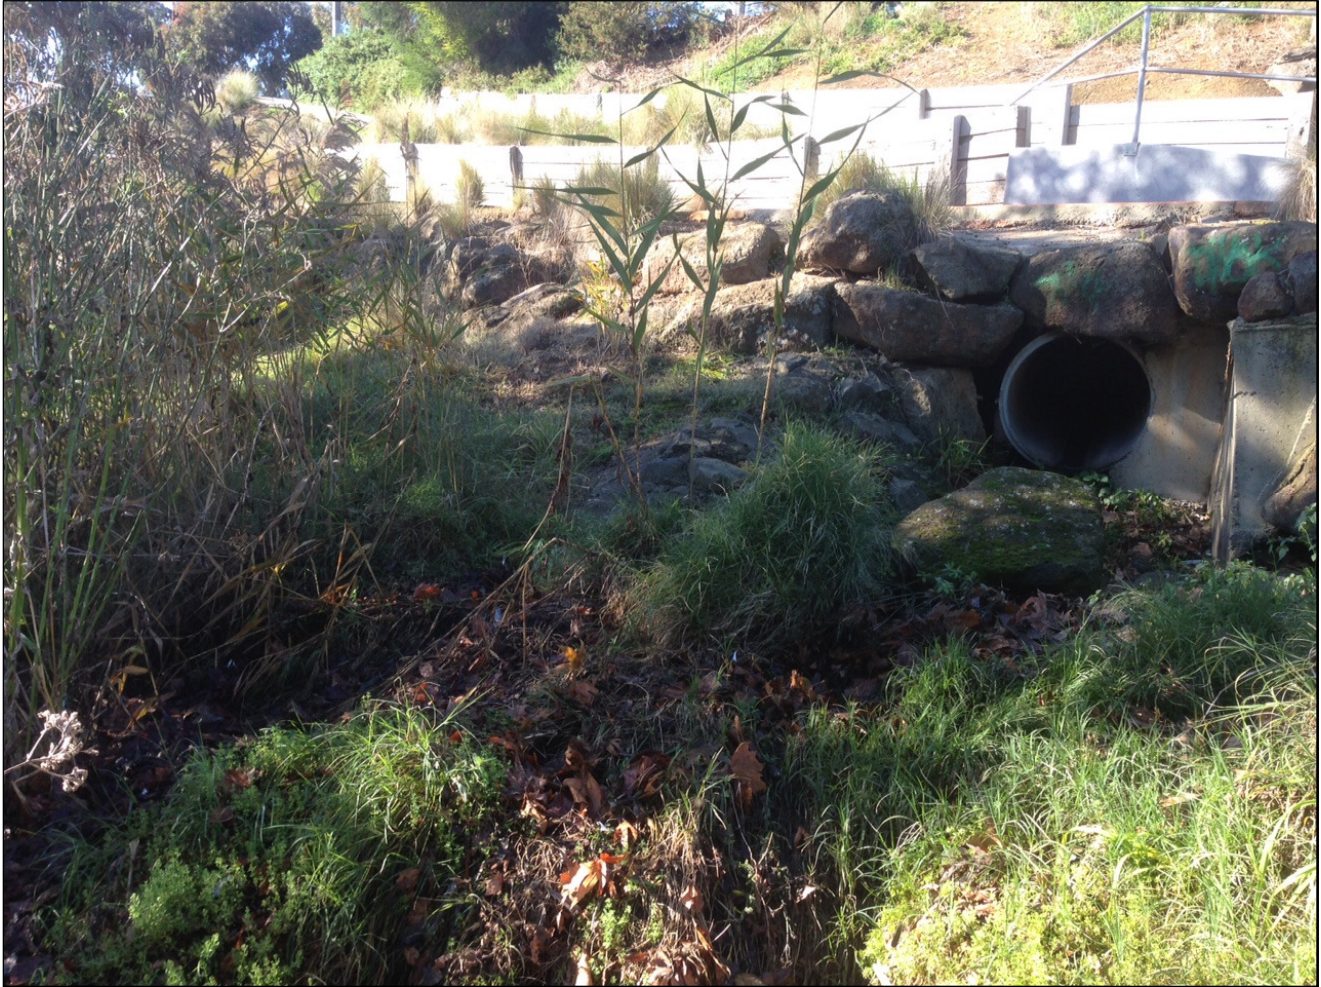
Bridge St Drain

Notes: This site drains some of the central area of the CBD. The site is not attractive, with exposed litter in the drain apron, broken footpaths with graffiti ridden signage, unsightly wooden walls lining the ramp down to the main path, and at least one traffic divider in the water. The amount of plastic litter deposited by stormwater on the apron is disturbing. The lack of plastic bottles and other containers at the drain may be due to weekly clean-ups by City of Wyndham, some of whose workers spoke with the research team during the survey on 28 Apr. However, plastic bottles are very evident under the railway bridge, where accumulated piles exist behind a wire mesh fence on railway property, spilling down into the river below the elevated walkway. *Azolla* sp. and scattered litter on the surface of the water make a picture here which shows a considerable litter load on the river at this point. What can't be seen are the immeasurable numbers of items of plastic which have gone into the river over the life of this drain.

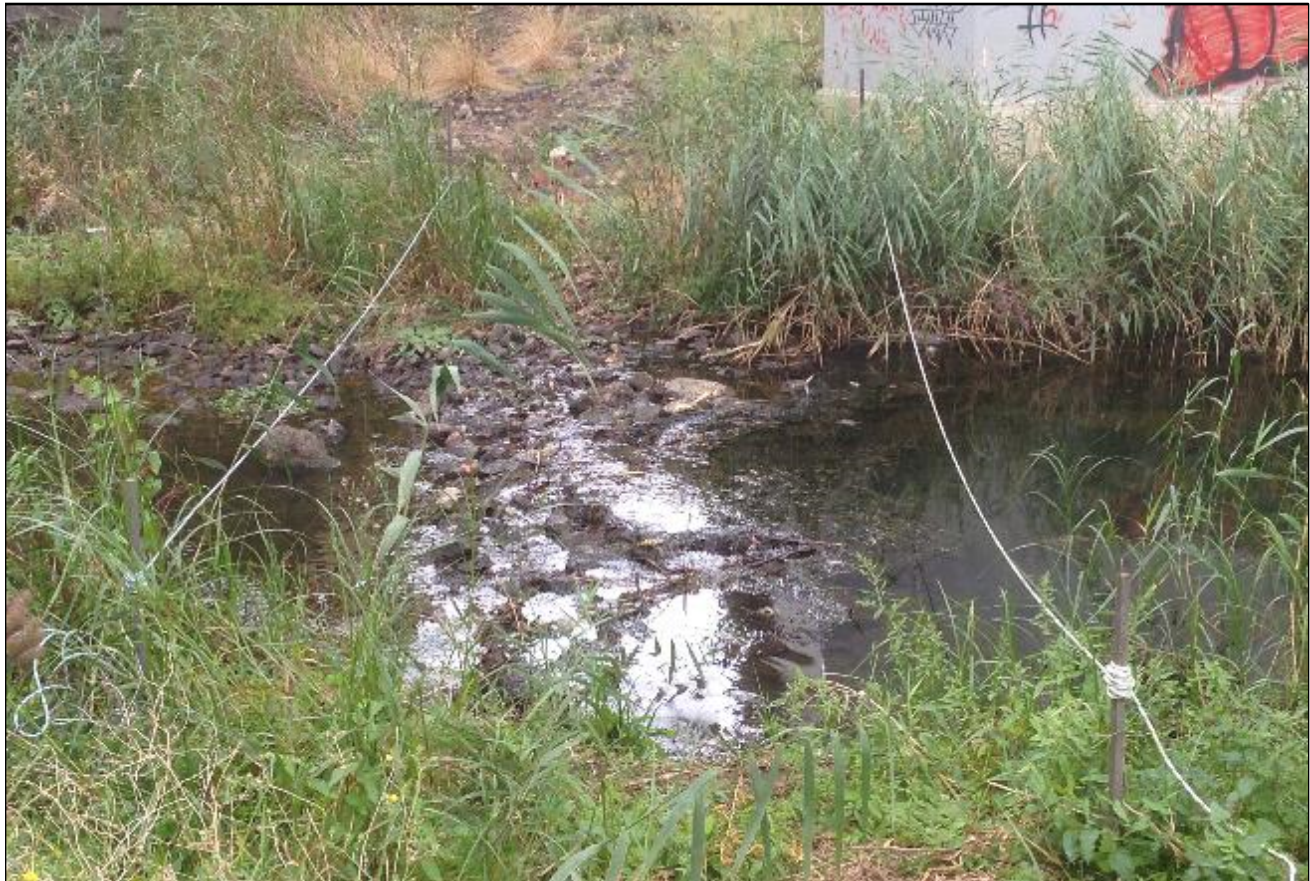
Litter Transect Maltby Bypass

This transect survey was undertaken by collecting litter found on the bottom of the river at a point where the water is shallow over the top of a 'ford' which is man-made. This transect is 20m downstream of a large drain on the east side, which appears to bring stormwater from the Concorde Cres area. The adjacent reed beds here are full of plastic containers and many plastic bags, including many used clothing collection bags. It is likely items do not stay long in this transect as even minimal flows in this shallow section were causing movement.

The 3 Mar 2015 data showed minimal data, totalling 8 items, but the survey was done by visual survey only, while an in-water, thorough hand search survey was completed on 30 May 2015, which resulted in finding 261 items. Drink containers found showed signs of being in the water for a long period, and polystyrene foam balls are estimated only (estimated in excess of 1000) as they were numerous and very difficult to see and collect

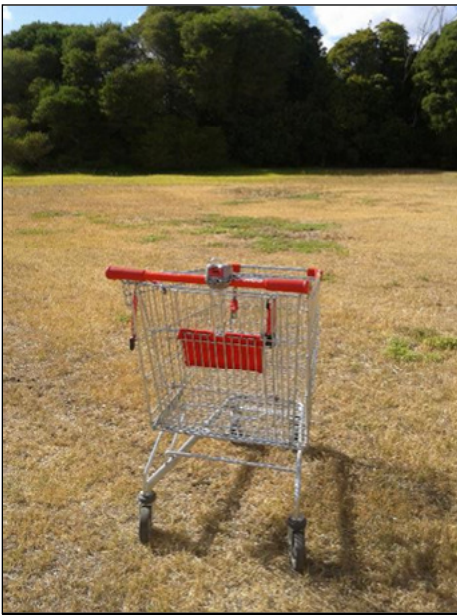
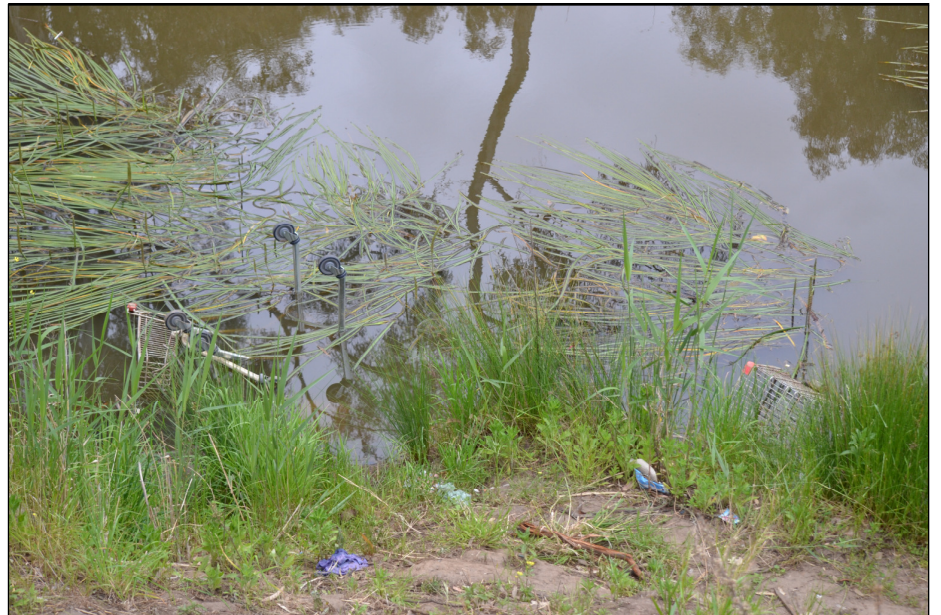
- Shopping Trolleys
 - o < 24 older trolleys in vicinity of Wyndham Park Piazza Bridge previously reported to Melbourne Water
 - o 8 new trolleys noted between Heaths Rd Bridge and Cottrell St reported via twitter to MW west team and others
- Large areas of mown grass and lack of riparian vegetation were seen in areas of the river
- Blue green algae noted commonly at sites from diversion weir pools to K Road cliffs, most commonly downstream from Maltby Bypass
- *Azolla* sp. coverage providing a 'snapshot' of floating litter items which would normally flow downstream or enter into reed beds
- Polystyrene foam present in litter findings and particularly serious load present in swale drain leading from Riverwalk Estate

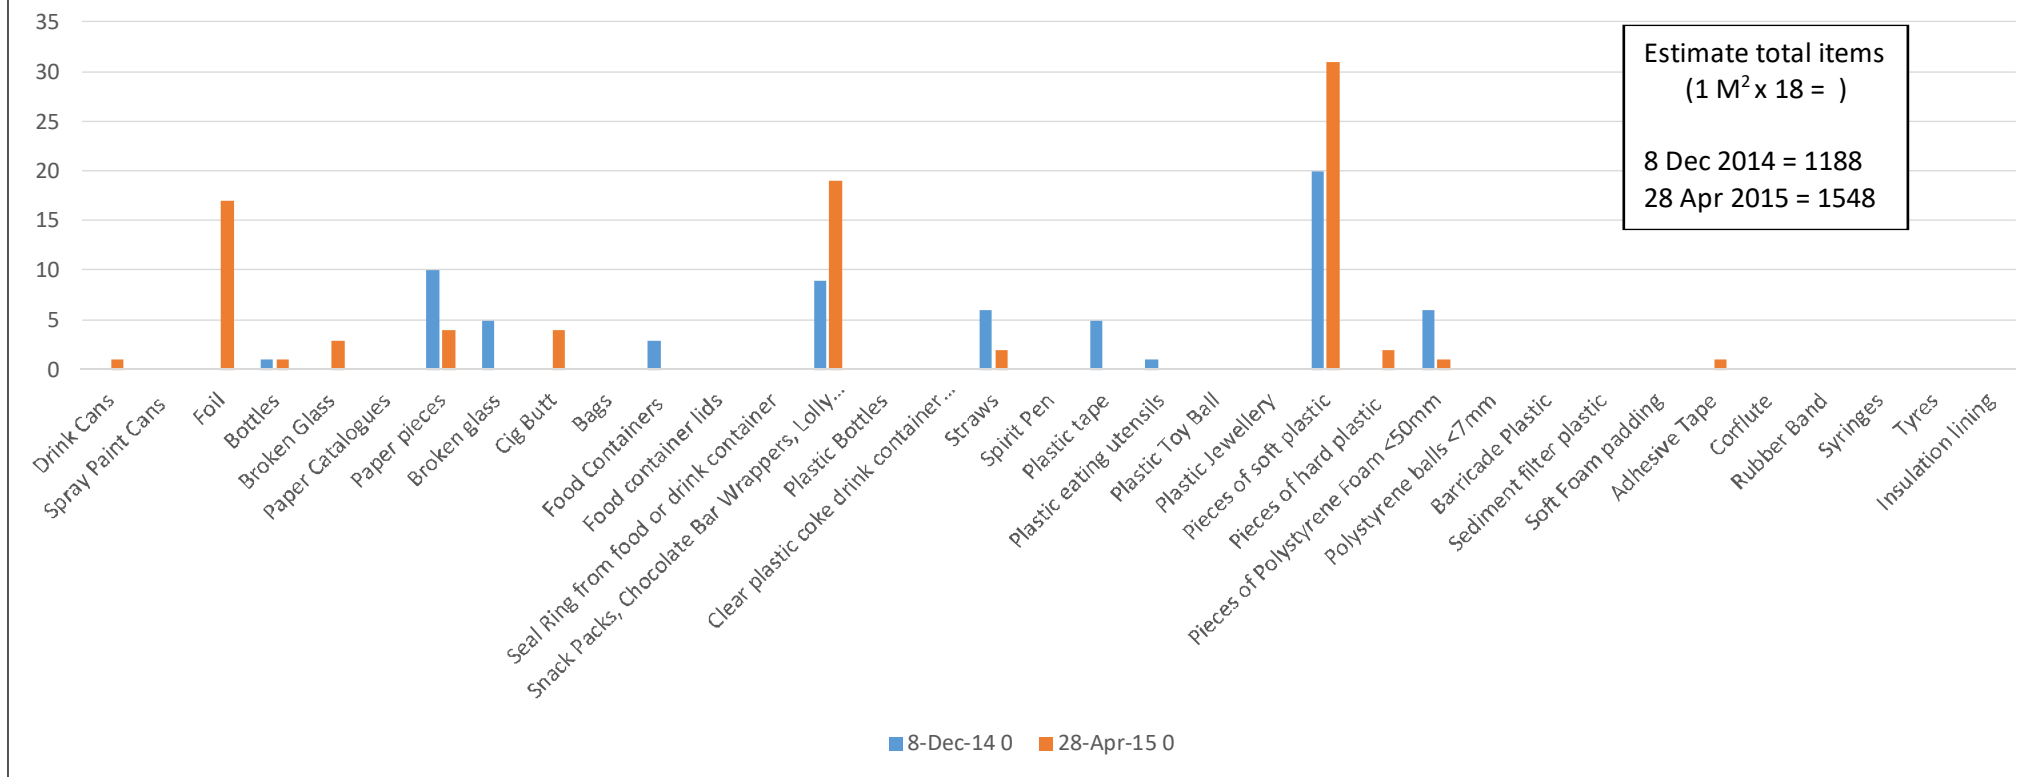
LITTER DATA 1

Bridge St Drain 1 sq m Grid 2014/15

(Total items estimated over 18sq m apron)

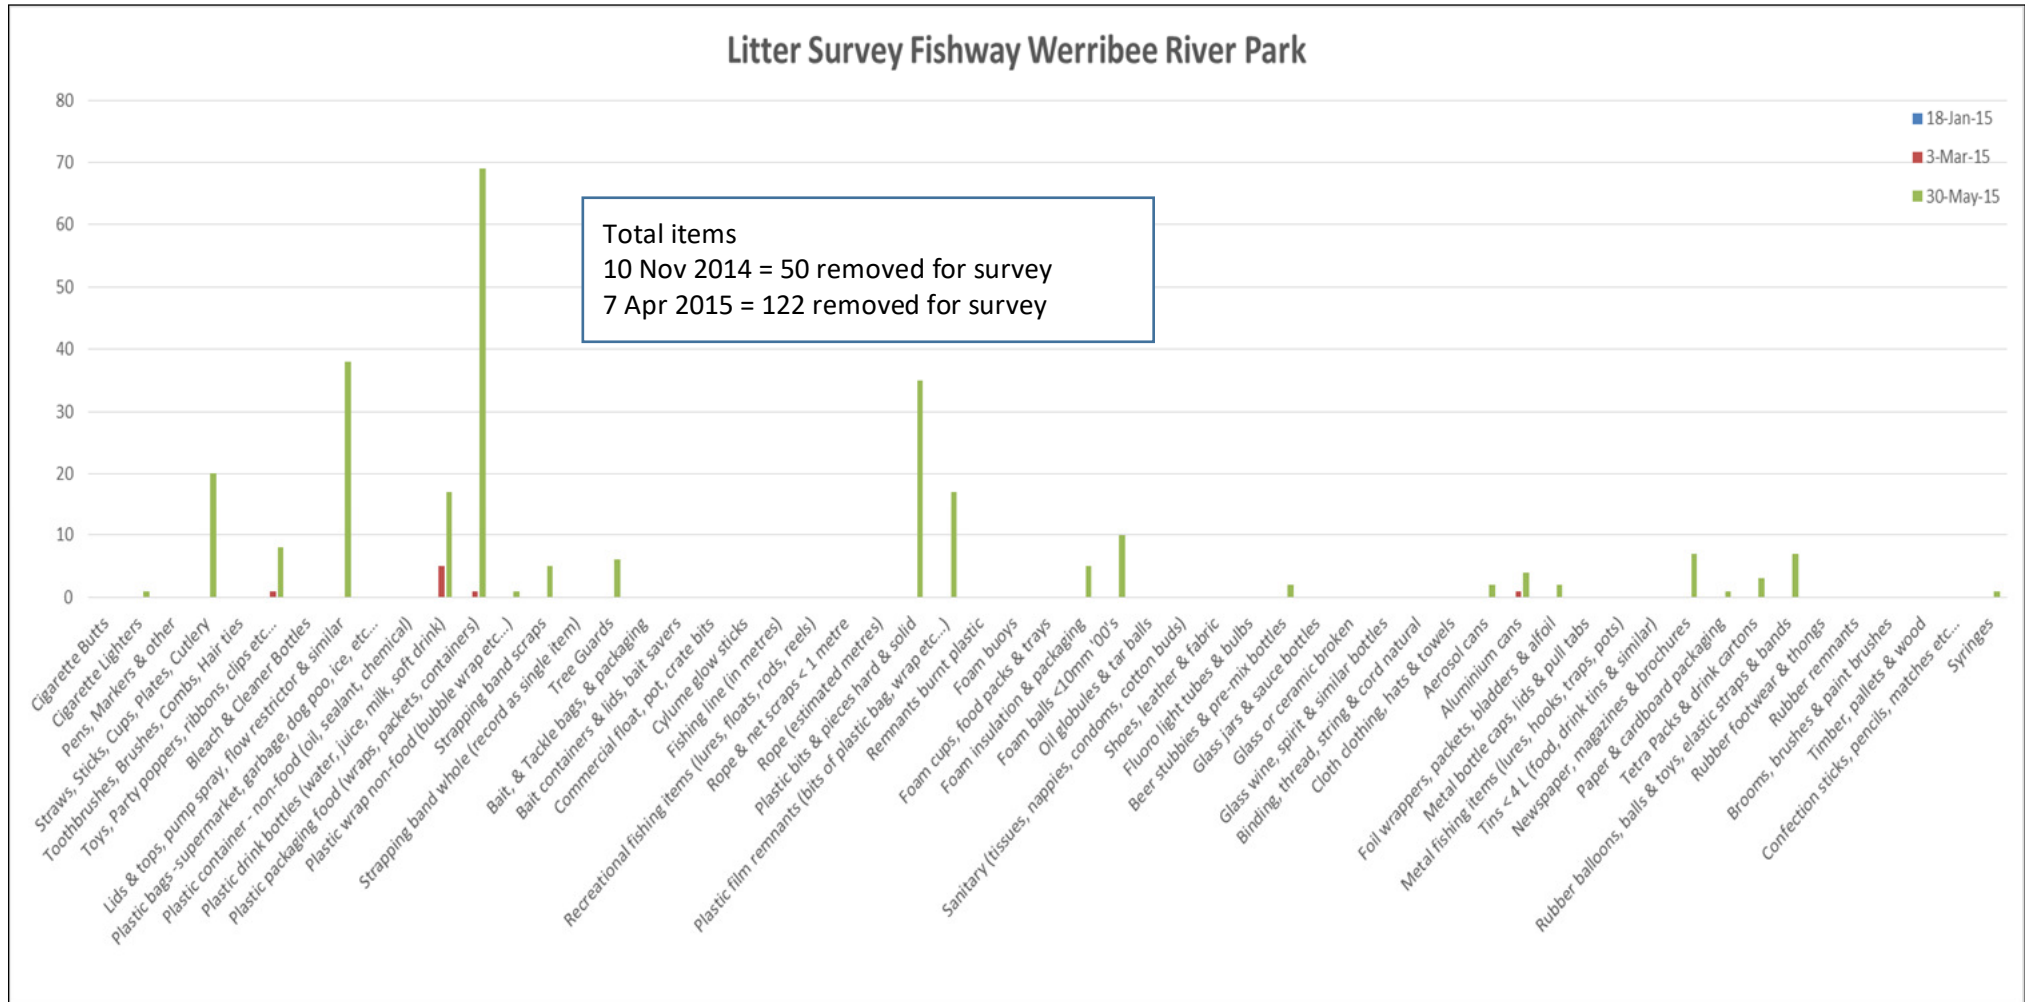
LITTER DATA 3

The 18 Jan 2015 data of zero for all categories was done when the fishway was just completed, and the visual survey in very clear slow moving water showed no litter was present at that stage.

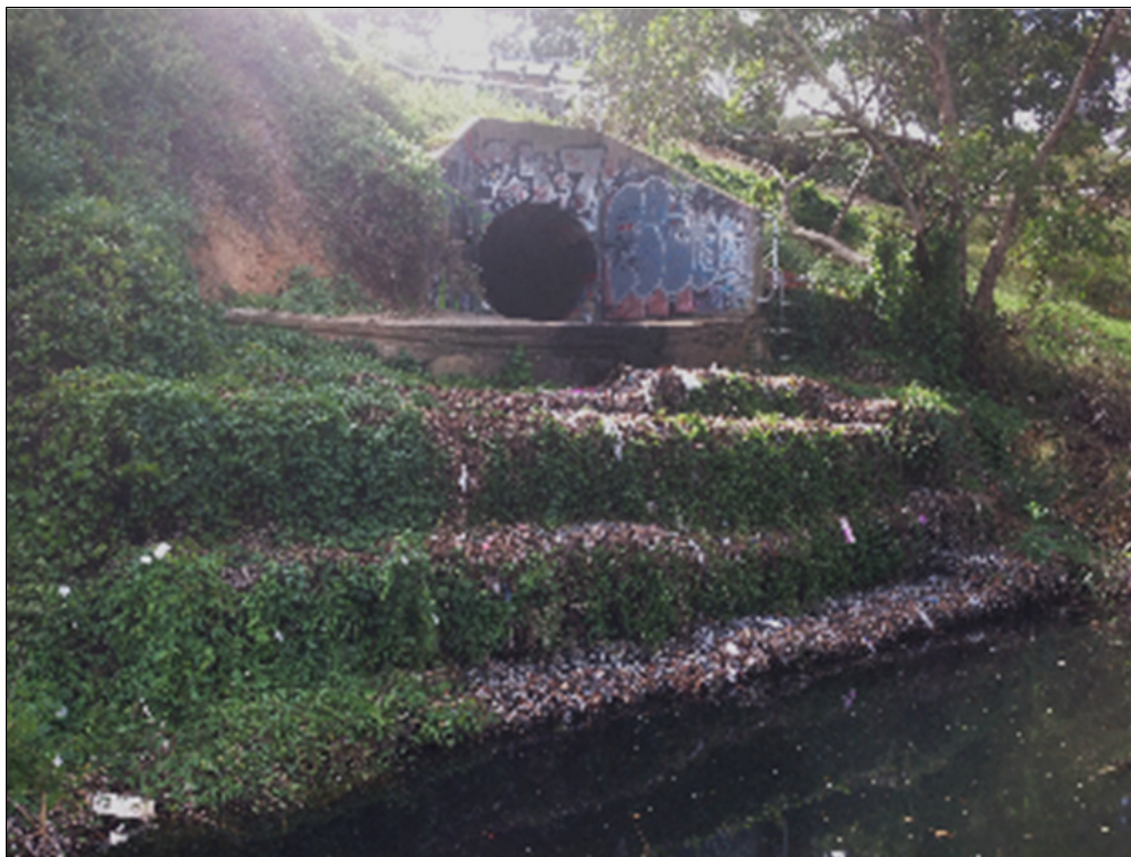
Photo left:

This large drain deposits all forms of litter into the river, and has a mal-functioning litter trap 3-4 metres inside the opening. There is an artificial rock wall 3-4 metres high immediately below the drain, the mesh of which captures many fragments of plastic bags, and many other items. The wall possibly assists the plastic to be fragmented into smaller pieces.

Discussions with Melbourne Water and City of Wyndham reveal that the Bulban Rd drain has not been cleaned on a regular basis for some years. It was noted the design of the litter trap poses problems due to dangers of a confined space.

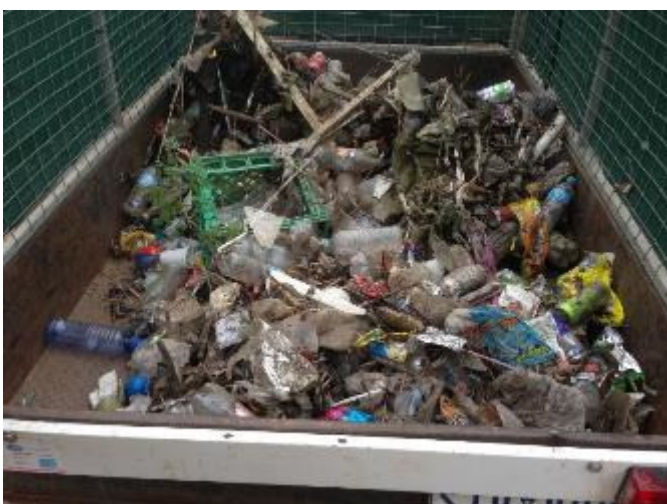
Photo left:

This sample of litter in a trailer was taken from the river below the drain, and shows some of the containers, cans, bottles and other plastic which was lying on the ground in the reed beds.

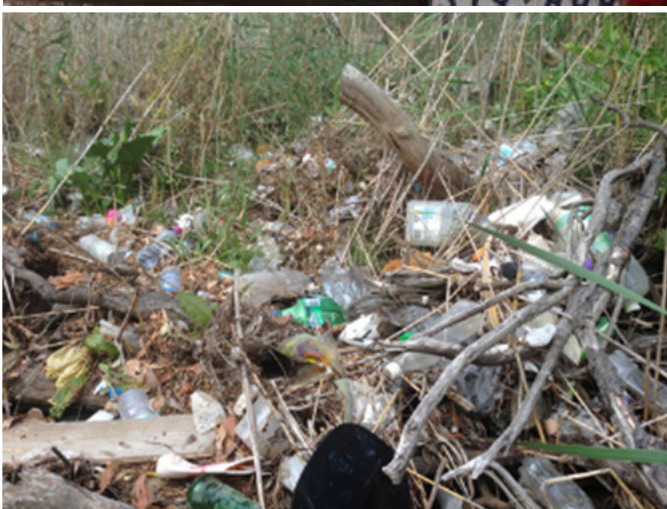
Photo below left:

Beside the water hole below the Bulban Rd Drain, this section of the reed beds was knee deep in places with litter, much of which was containers and other plastic.

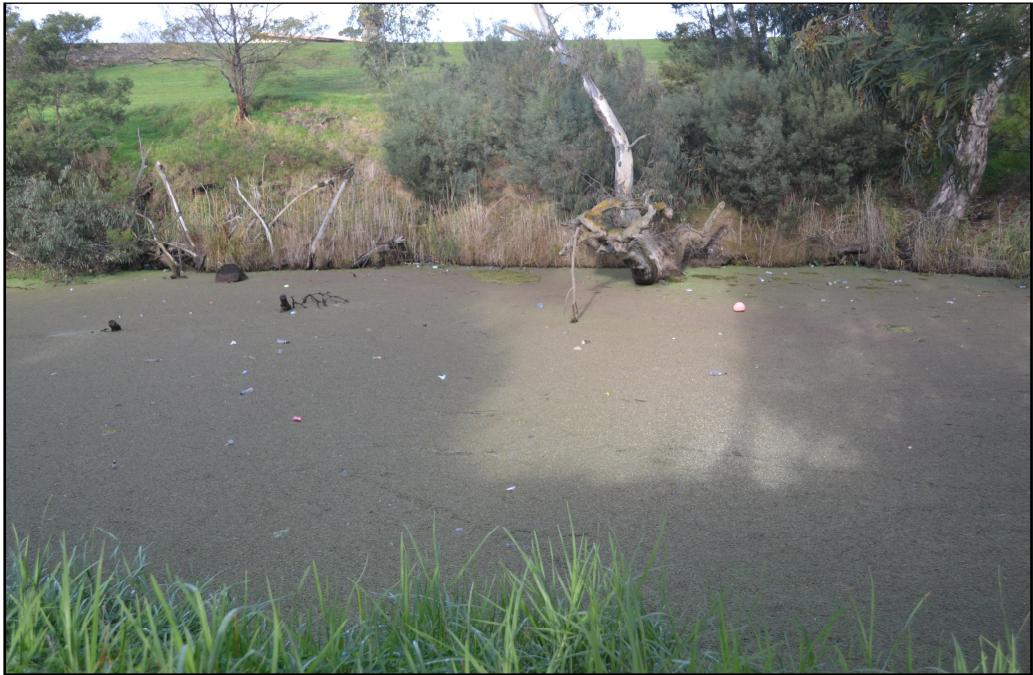
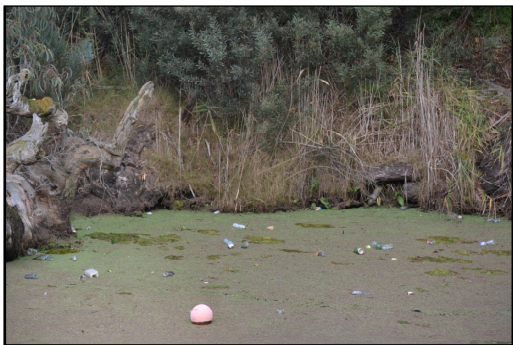
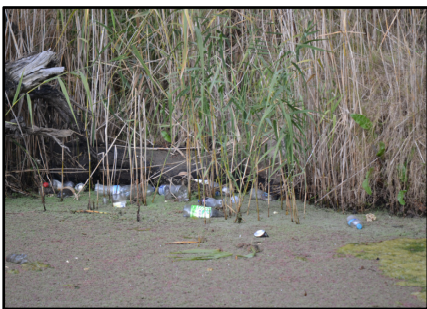
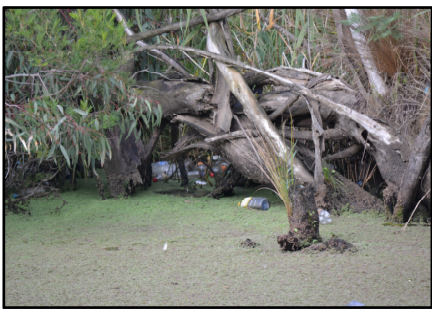
At the time the river had more than four kilometres of *Azolla* sp. coverage at 90+% of the surface. In all of those areas, adjacent to stormwater outlets, litter can be seen floating. Reed beds whether in *Azolla* sp. affected areas or not also hide a large number of floating litter items from view.

Photos below: *Azolla* sp. covered river with view of litter strewn surface and litter in reeds and river snags

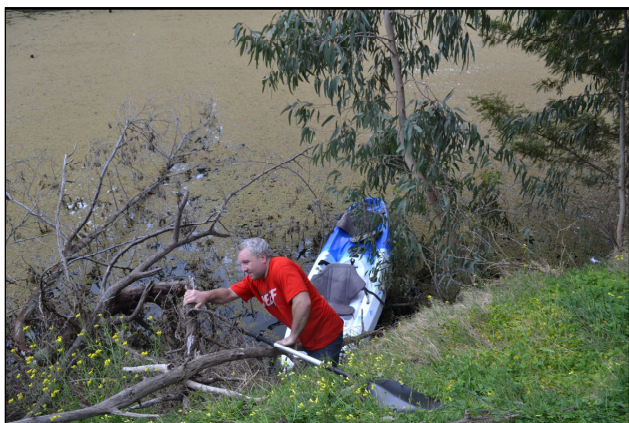
On river Survey Guyra Court Sat 5 Sep 2015:

We surveyed the river by kayak in this location from a point four hundred metres upstream from where the river narrows at Nadda Court. Entering the water from the upstream end of Manorvale reserve, we travelled downstream to the narrows, and returned. Observation while travelling showed an item of litter every two metres in the Azolla coverage, which at the time was covering about 75% of the river surface. The items ranged from dozens of drink containers, hundreds of polystyrene balls up to 10mm in size, chocolate or other snack bar wraps, snack pack wrapping, an inflatable device, toys, balls, plastic bags, clothing items and a shopping trolley. Our estimate of litter items of visible size to be more than 10,000.

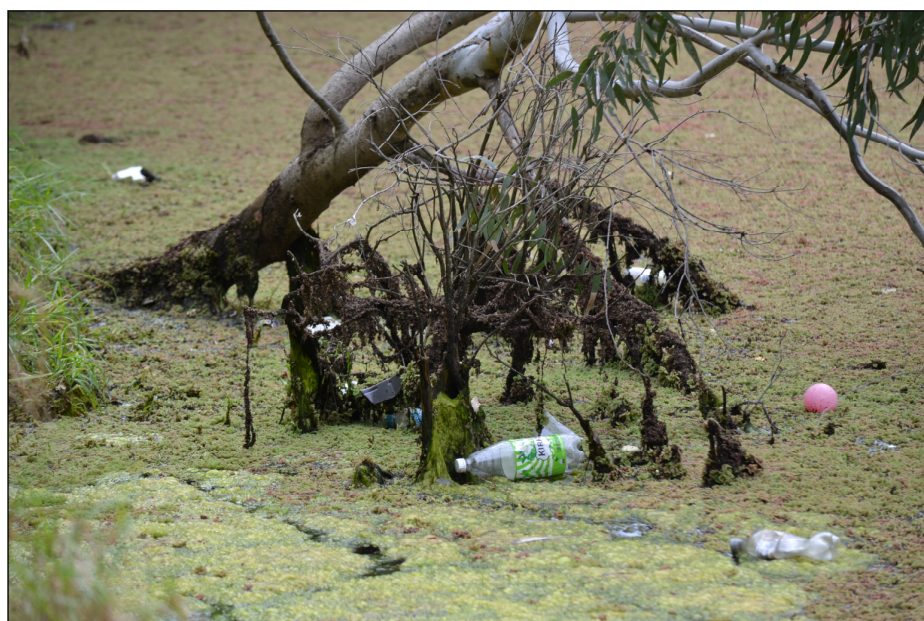
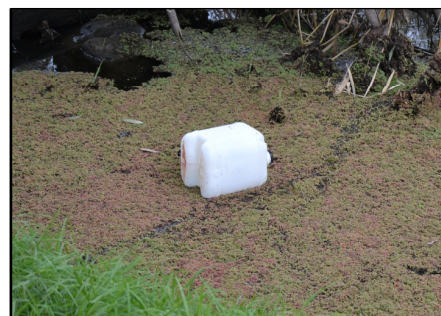
Photo left: This shot shows a typical scene around woody debris. Azolla coverage holding containers, a ball, polystyrene foam pieces and plastic bag in the locality. **Photo below:** Large container which had travelled 200 metres since Mon 31 Aug 2015.

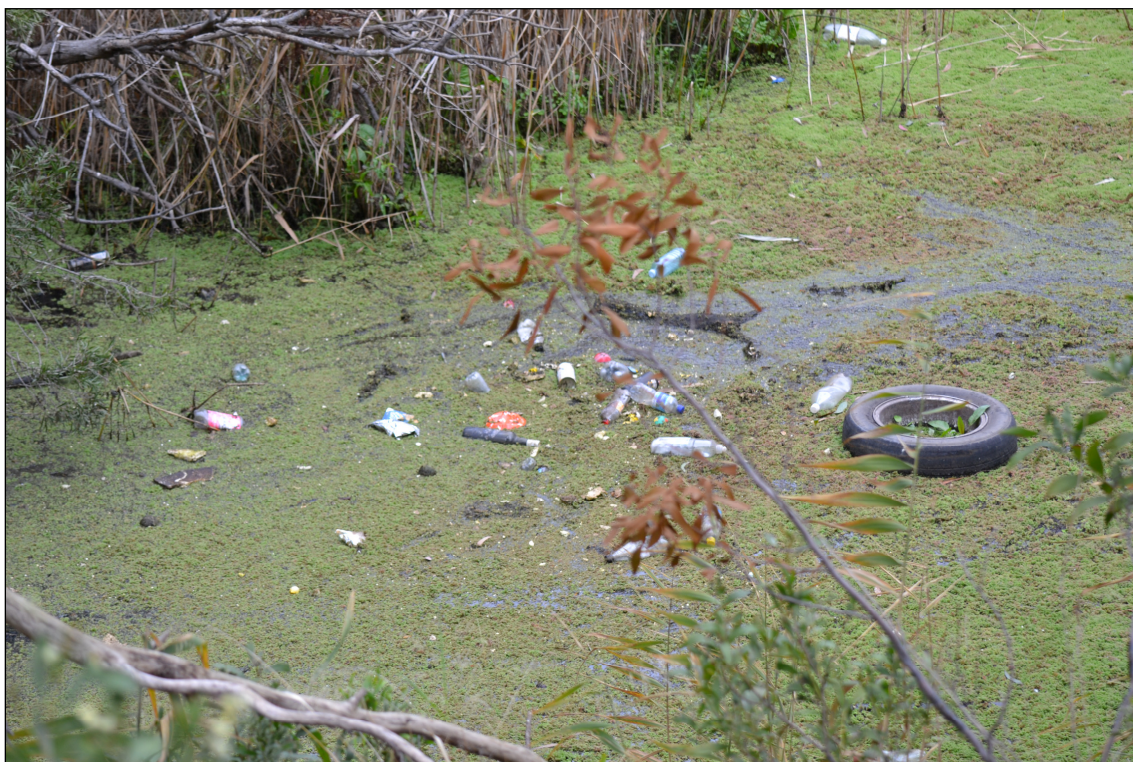
Photo left: This scene was photographed at the end of the narrows at Nadda Court Sat 5 Sep 2015.

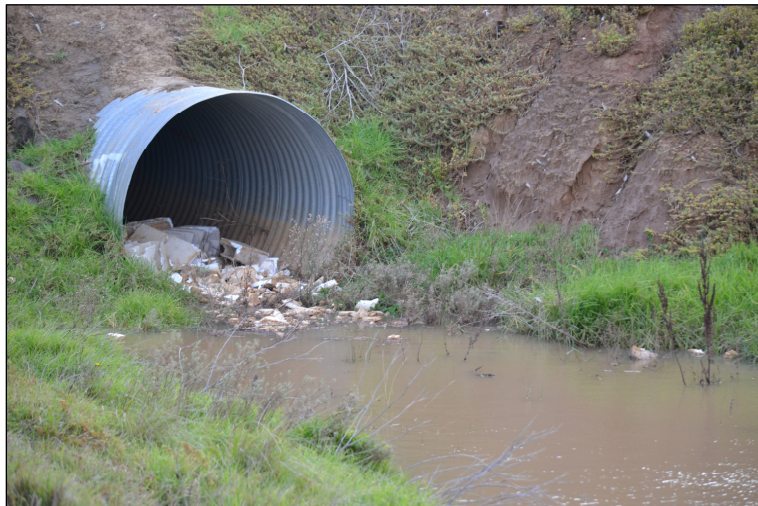
Sun 10 May 2015:

This site was monitored over a period of time due to the unusual building of a deep swale with steep sides in a housing development. The Riverwalk Estate is being developed by Excell Gray Bruni for Vic Urban. The swale takes stormwater to the Werribee River, passing water under Old Farm Rd on the way to the river through the pipe in the photos. Litter of all kinds around here upstream of Old Farm Rd, and there appears to be no effective control or management of the litter.

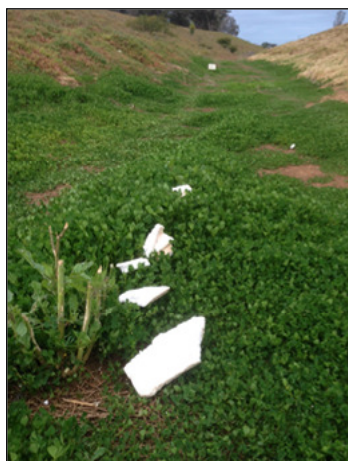
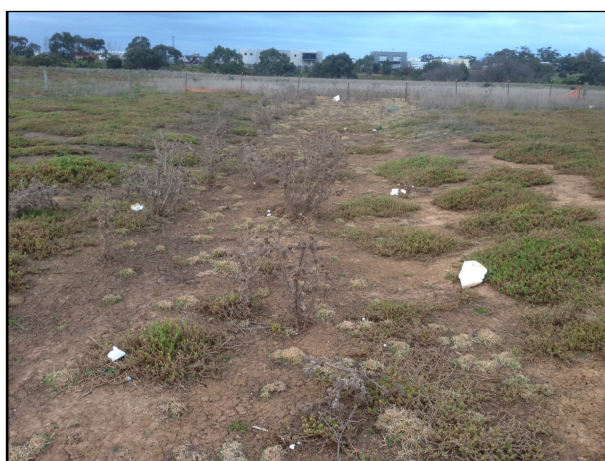
(L Below) Polystyrene in channel on way to river Tue 8 Sep 2015. (R Below) Polystyrene at end of swale

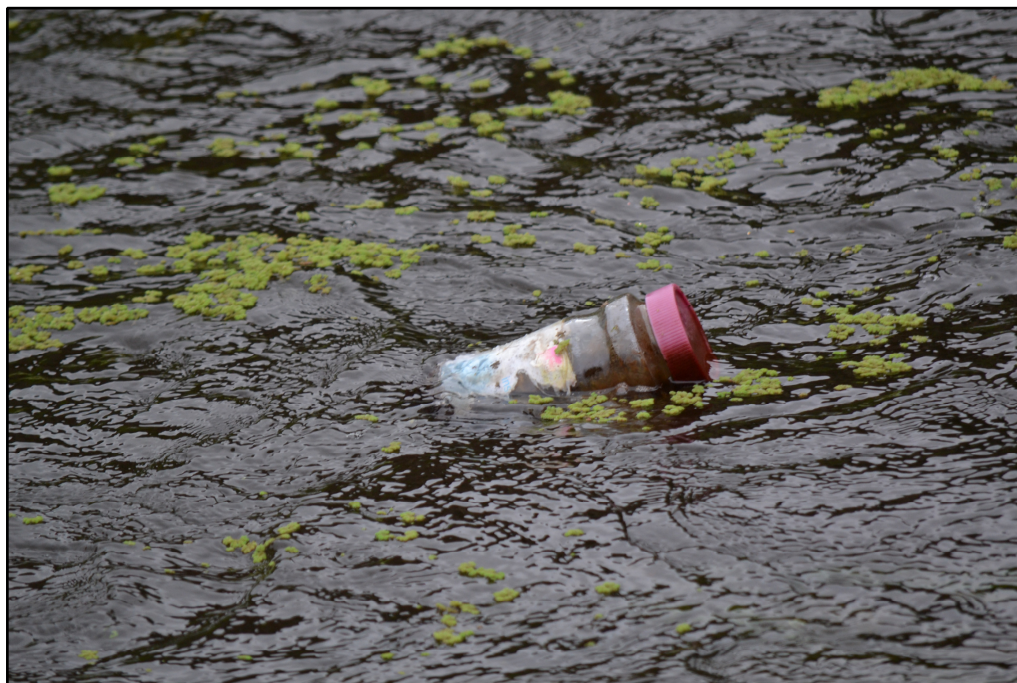
Photo above: This jar was photographed as it passed under Cottrell St bridge on Thur 12 Feb, and was identified when next seen two kilometres downstream in the old swimming pool at Bungey's Hole on Tue 24 Feb 2015, when WRivA carried out an inspection of Bungey's Hole for Clean-up Australia Day. See our articles on the CuAD activity and tracking an environmental flow:

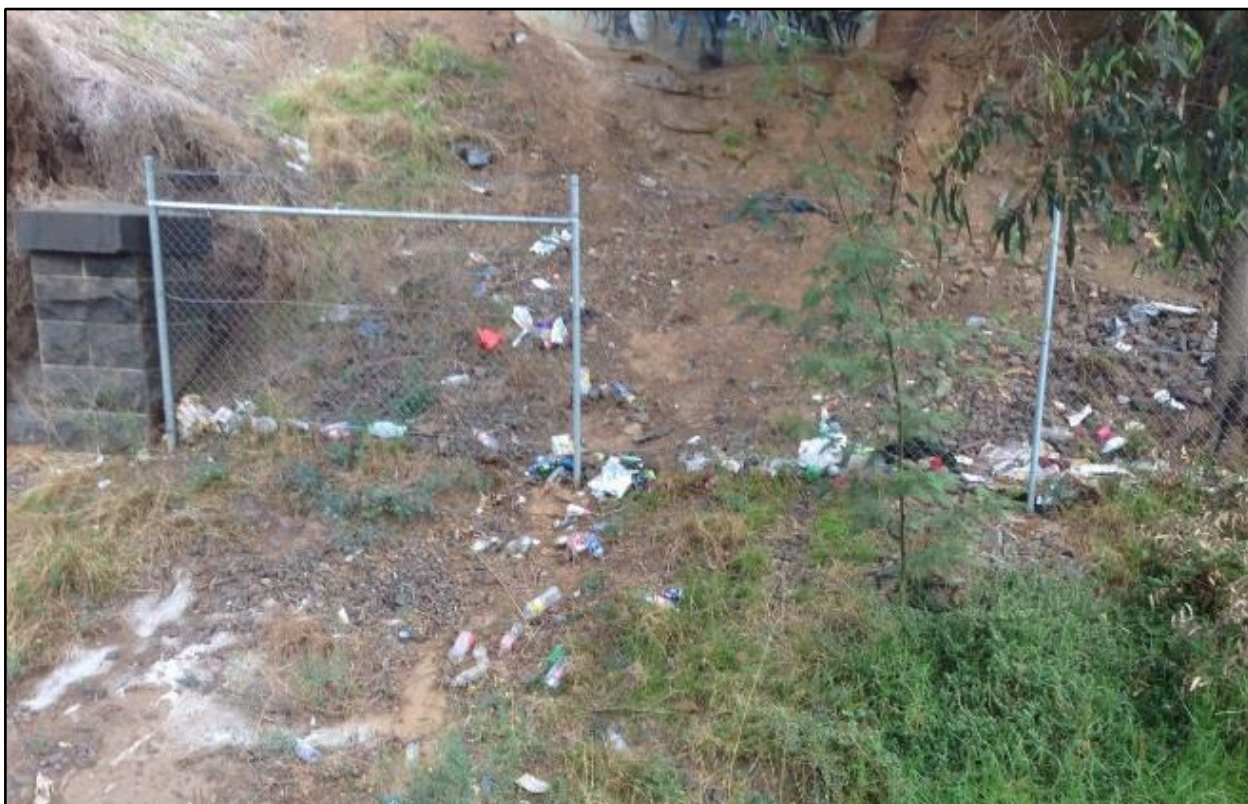
Litter load under Rail Bridge, from railway property Wyndham Park

There is a heavy concentration of litter here, much of it fully visible in Azolla, giving the researchers an excellent snapshot of litter passing by this point.

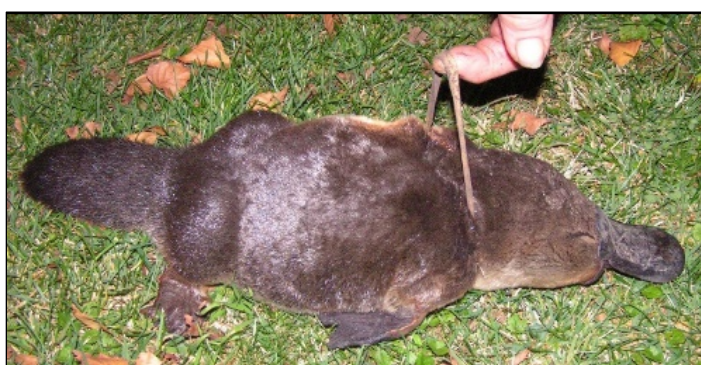
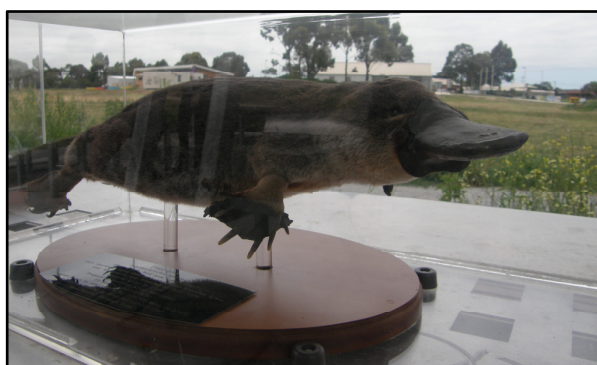
Photos below: Platypus found dead in Werribee 2004 with litter injuries, then was mounted as a taxidermy specimen for educational purposes.
